A Preliminary Investigation of Physicochemical and Microbiological Parameters of Natural Springs Found in Linden, Guyana

Original Research Article

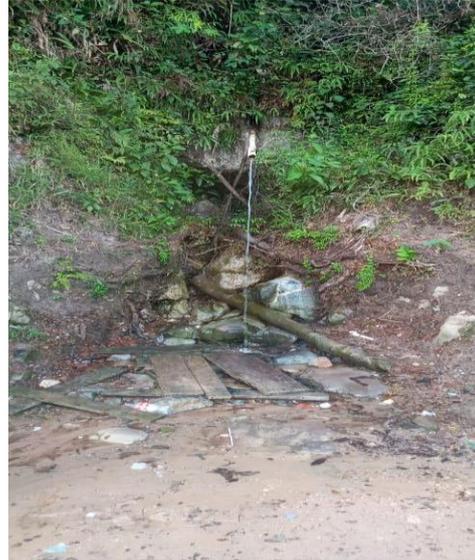
GPS: N05°57.740' W058°17.119' This spring had indications of nearby pollution (Fig. 2). The site displayed hilly terrain with nearby isolated settlements. The spring water was clear. There appeared to be dense vegetation types with mixed soil types of sand, rocks, and loam.

Fig. 2. Coomacka Spring in Linden

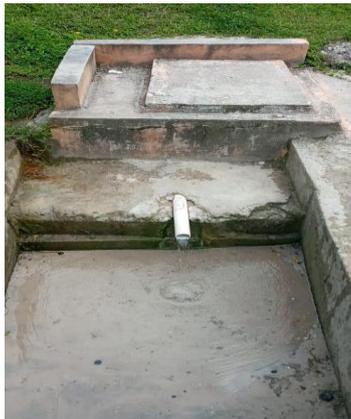
GPS: N06°00.025' W058°18.616' Vegetation Type is sparse and soil type is sandy (Fig. 5). The terrain was hilly. Settlements were found to be linear. There was no pollution noted.

Fig. 5. Silvertown Spring, Linden

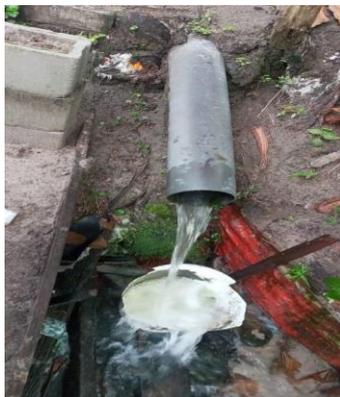
GPS: N06°00.458' W058°18.097' There was no vegetation type at the location (Fig. 6). Soil type of sandy and hilly terrain. Settlements were dispersed and pollution absent.

Fig. 6. Victory Valley Spring, Linden
