Performance Evaluation of Semi-Solid Set Sprinkler Irrigation System at Field Scale

Original Research Article

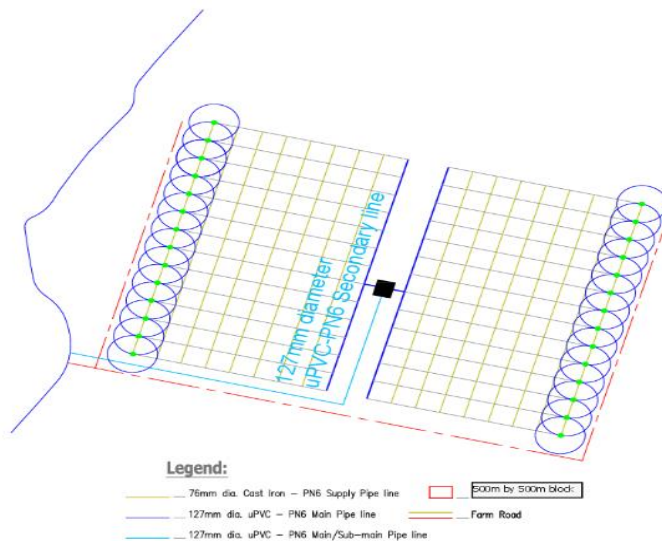
Fig. 2. Semi-Solid Set Sprinkler Irrigation System at Mkulazi Sugarcane Estate

This system is one in which laterals are permanently fixed throughout the season, while each lateral has only one sprinkler and riser that is moved along the lateral for each irrigation event. During irrigation, all the other sprinkler positions on the lateral are shut except the one operating. Blocks are divided into two, with each side having a manifold that connects to the laterals, and a hydrant located at the middle of the block as shown in Fig. 2. and Table 1.

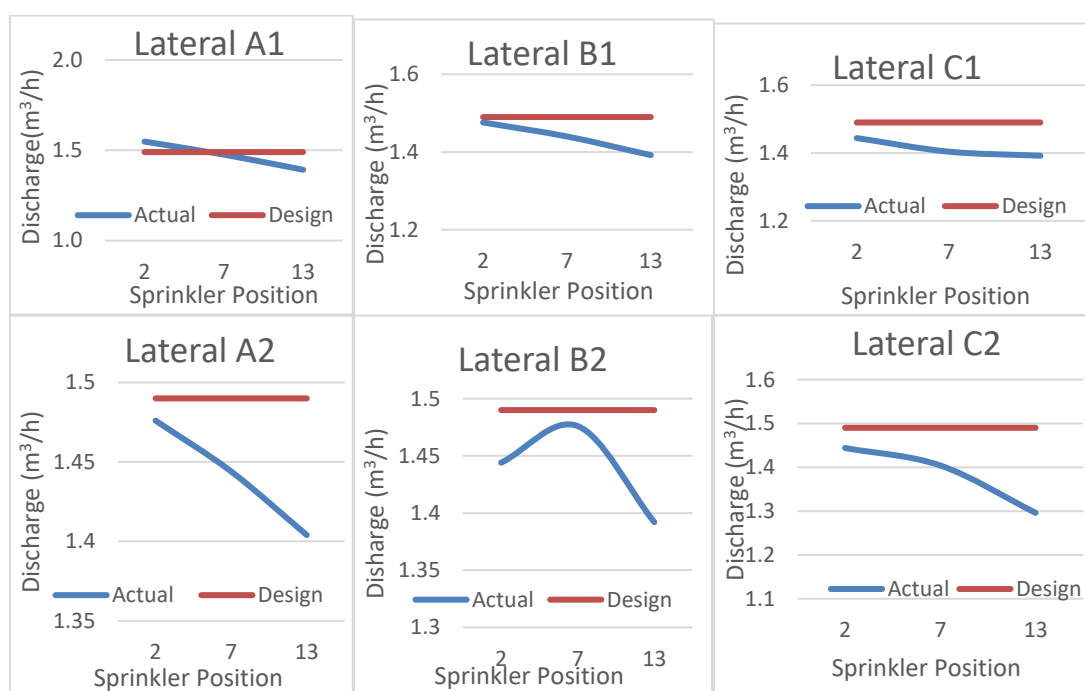
Fig. 5. Sprinkler discharge rates along the selected laterals

It was however noticeable that CU and DU values in the third sections of measurements in all selected laterals were relatively low as compared to the other sections. This was associated with observed accumulation of silt at the ends of the laterals after irrigation. Since there is only one outlet sprinkler at a time, particles present in the system are carried and deposited at the ends of the laterals. Due to this, sprinklers operating around this area experience

low pressures due to blockages, and hence low uniformity. As explained by Gurmū *et al.*, [25] river sediment brought in with the irrigation water via intake structures is one of the sources of sedimentation in irrigation systems, which could be the case at Mkulazi Sugarcane Estate. These sediments cause adverse effects specifically on pumps and sprinkler nozzles, creates turbidity and impairs water distribution [26]. Although it is not feasible to prevent the sediments entering the irrigation system entirely, proper filtration at the intake can help alleviate this challenge. The study also found out that towards the ends of the selected laterals, the discharge rates were lower. This was related to the fact that pressure is lowest at the distal end and progressively increase towards the source in a level lateral [23], which in return leads to a gradual decrease in sprinkler discharges towards the end of the lateral.

The study also revealed that, at the tail ends of the selected laterals, there was a notable decrease in discharge rates when compared to the upper sections, as depicted in Fig. 5. This decrease in discharge rates can be attributed to not only the expected head losses along the lateral, leading to pressure reduction towards the tail end but also the accumulation of sediments at the ends, which led to clogging and consequently resulted in substantially reduced discharge. In certain positions of the sprinkler system, this accumulation of sediments even led to complete blockages. This situation results in adequate irrigation depth at the upper section of the lateral, but insufficient watering at the tail end. The operation of the SSSIS offers a chance to rectify this issue by extending the irrigation duration when the sprinklers are functioning at the tail end. As the system progresses towards the upper section, the irrigation time can be gradually reduced to ensure optimal water application without any runoff, particularly at the upper end.

Proper filtration at the intake should be enhanced to minimize the amount of sediments that get into the system and are then deposited at the ends of the laterals. To control regular lateral lockage, the operators should ensure regular flushing of the laterals.

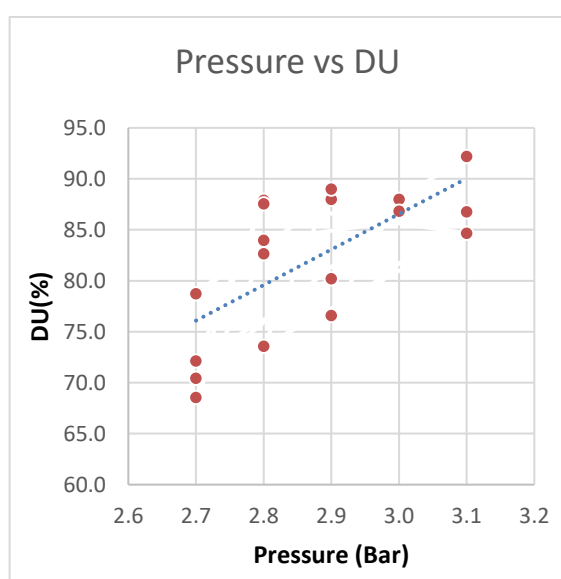
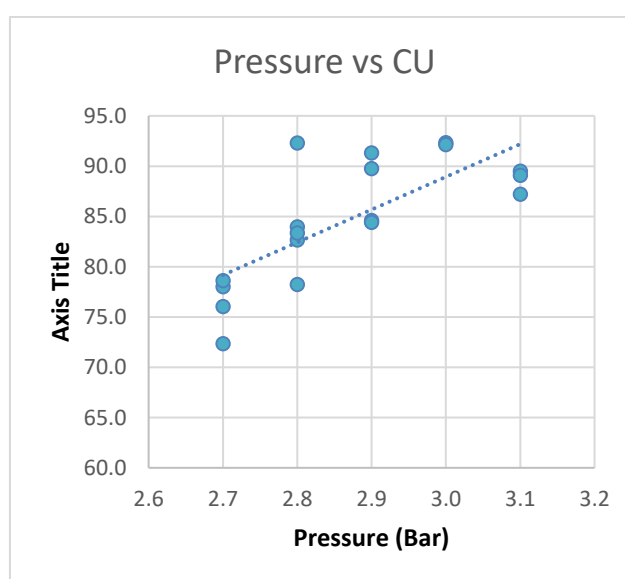
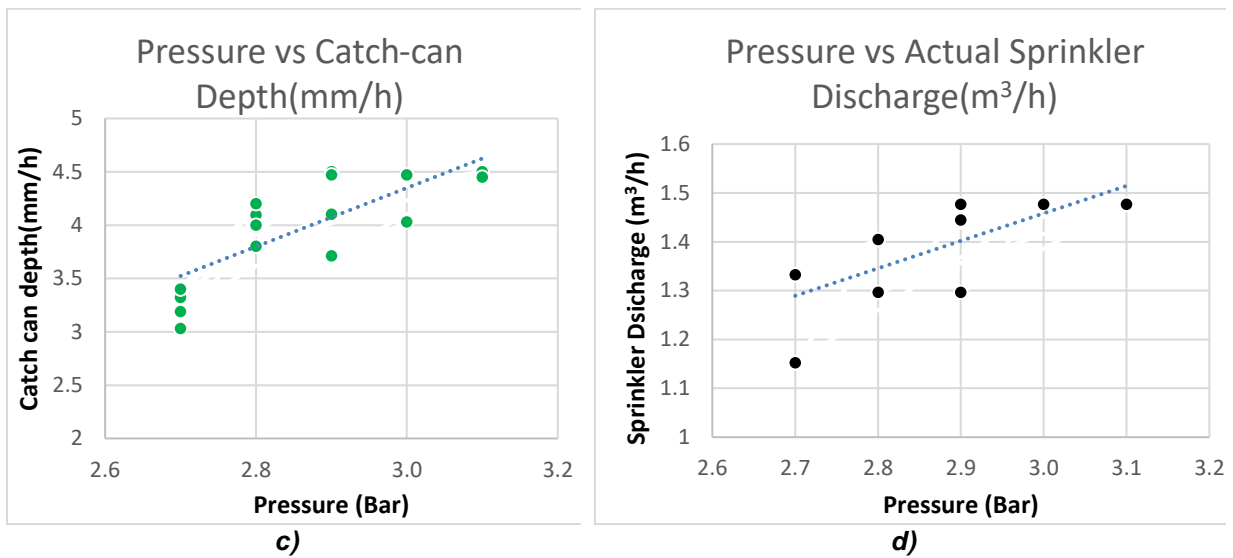
Fig. 6. Relationship between pressure and other uniformity and efficiency parameters

Sprinkler Efficiency: Fig. 6 shows the relationship between the uniformity parameters measured as well as the catch can depth and actual sprinkler discharges. The results indicated a direct relationship between pressure and CU, DU, catch can depth and actual sprinkler discharges. Since sprinkler operating pressure affects sprinkler discharge rate and amount applied, it is generally accepted that the limit of discharge varied in different parts of laterals should not exceed 10% of average discharge. Pressure variation constraints shouldn't be more than 20% of the normal operating pressure to improve performance. Above this limit, more pressure variation would affect water distribution uniformity (DU), resulting in certain areas of the surface receiving more water than others.

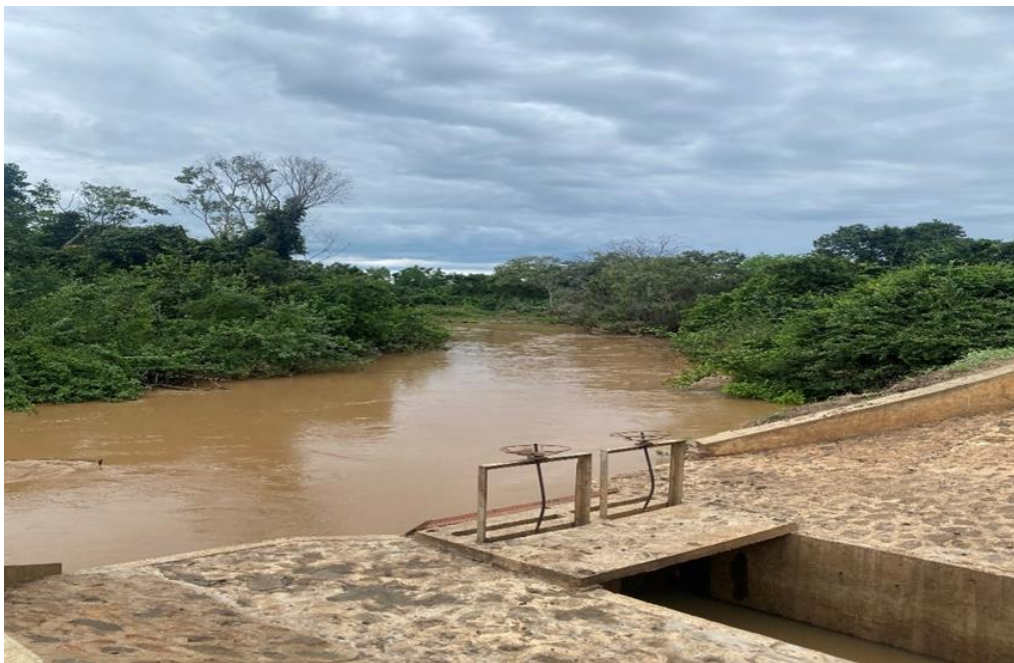
Fig. 7. Location of water intake at Wami River

The absence of a filtration system at the intake enables sediments from the river to move into the system and are deposited at the ends of the sprinkler laterals. This is reflected by the low discharge rates at the ends of the laterals. Further observation showed that the location of the intake could one of the reasons for excessive accumulation of sediments in the system. The intake as shown in Fig. 7 is located directly opposite the slow-moving side of River Wami, where deposition of sediments carried from upriver occurs.
